Memo-Servicing & Technical Info

Number 70

Subject: Saf-Fire 9 Litre Water Extinguisher

REF: FAULT ON VALVE MANUFACTURER'S BRASS BODY FORGING

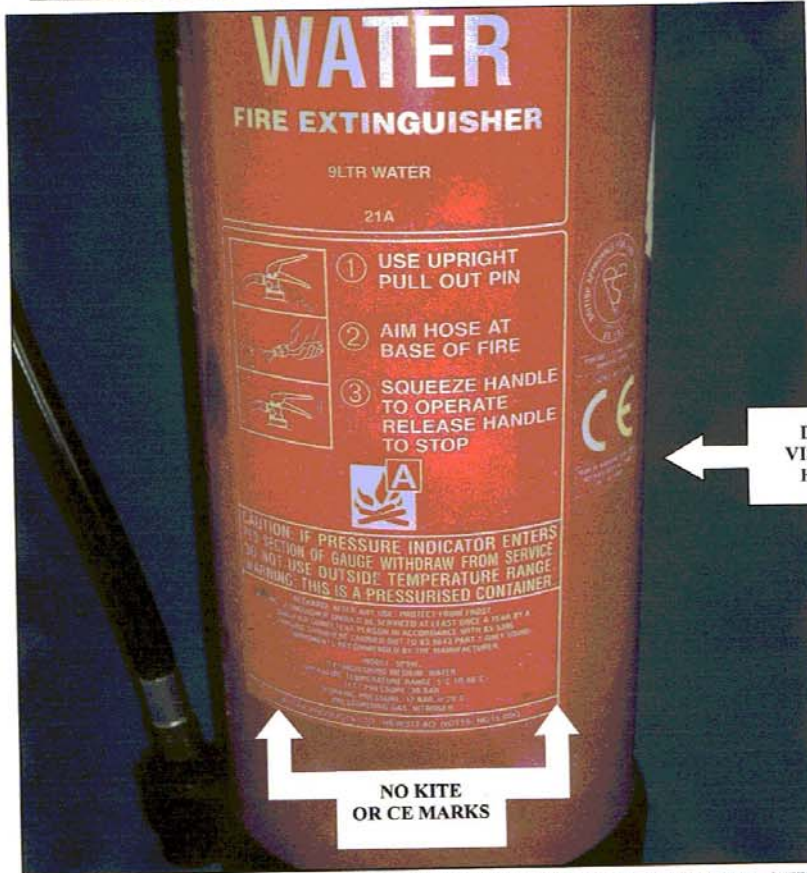
THIS APPLIES ONLY TO SAFFIRE 9 LITRE WATER EXTINGUISHERS MANUFACTURED BETWEEN MAY AND NOVEMBER 2004 WITH BATCH NUMBERS FROM 0550 TO 0660

IMPORTANT BEFORE REMOVING THE EXTINGUISHER FROM THE WALL;

CHECK THE KITEMARK AND CE MARK, IF THEY BOTH APPEAR ON THE FRONT LABEL THERE IS NO NEED TO CHECK FURTHER.

SHOULD THEY BE LOCATED ON THE RIGHT HAND SIDE CHECK THE DATE ON THE CE MARK IF THIS IS 2004 CHECK IF THE EXTINGUISHER HAS LOST PRESSURE

IF YES REMOVE THE EXTINGUISHER FROM THE WALL BY THE BODY AND NOT BY THE HANDLE

CHECK THE BATCH NUMBER ON THE BACK OF THE EXTINGUISHER NEXT TO HANGING BRACKET IF IT FALLS BETWEEN 0550 AND 0660 INVERT THE EXTINGUISHER, REMOVE THE PIN AND RELEASE ANY REMAINING GAS
