Memo-Servicing & Technical Info

Number 86

Firemaster 9Ltr Water (WSP 9000)

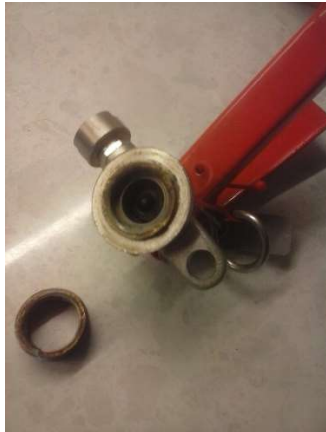
Below is a photograph of a failed extinguisher-head collected from an IFEDA members' customer following a phone call explaining that one of their extinguishers had exploded.

The unit in question is a Firemaster 9Ltr Water (WSP 9000) model, manufactured in 2006. It was discovered that on arrival at the premises the office was found to be wet and the head had detached from the body of the extinguisher. The neck thread on the valve had just given way and detached from the can. Fortunately, no major damage had occurred other than a wet floor, but the consequences could have been worse had this happened when people had been in the vicinity or indeed when the unit was in use or being serviced. This unit had been discharge tested and refilled twice in its life and no apparent faults had been identified.

As the manufacturer of this product no longer exists we cannot liaise with them and care must be taken if you have any (or come across any) of these units.

The only information we have to hand is that where the manufacturing date is marked on the can as 2006 this is followed by the bracketed digits 187. The unit was manufactured under the Kitemark Licence No.53428.
